Test Report No: RJ5131P-2

SUBJECT: Assembly testing of Tefute Stone Coated Metal Roofing system to UL 2218, Impact Resistance of Prepared Roof Covering Materials

SAMPLE ID: Tefute Stone Coated Metal Roofing System. See Preparation, Appendix and Photograph section for additional details of assembly and profile tested.

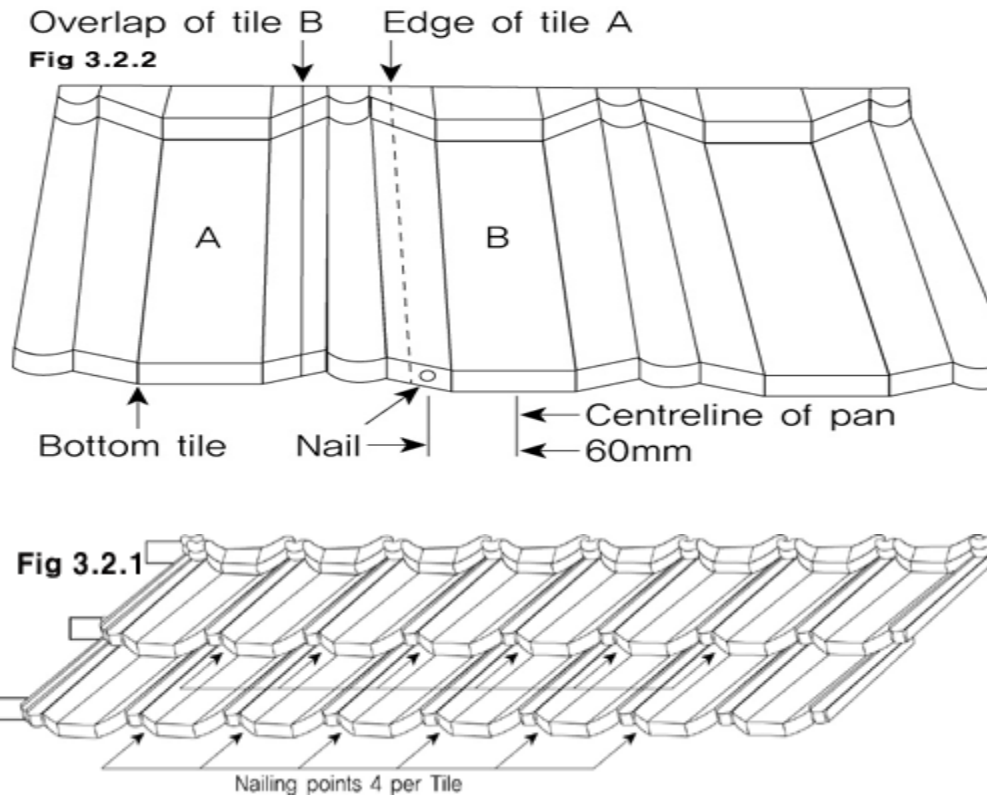
Diagram 1: Nailing Pattern used in test assemblies followed from “Tefute Stone Coated Metal Roofing System” Installation Procedure provided by the client.

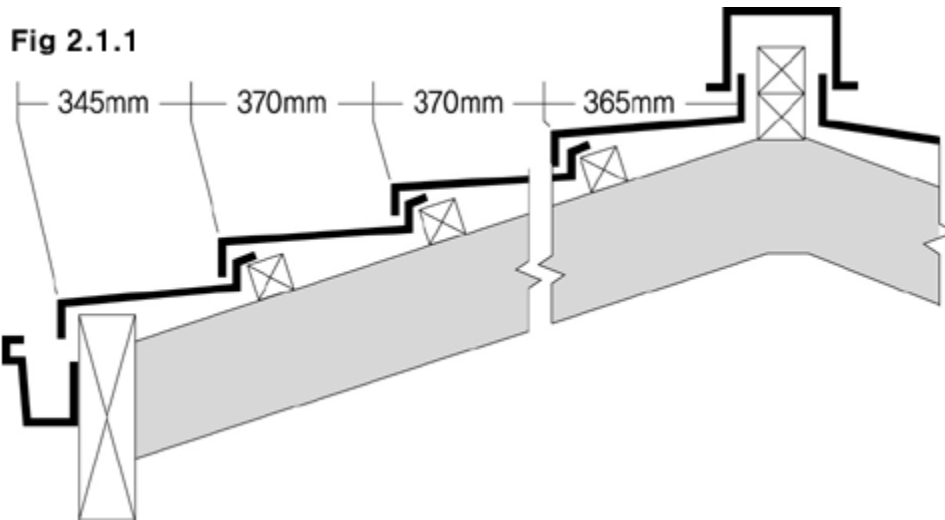
Diagram 2. Installation Batten Spacing test assemblies followed from “Tefute Stone Coated Metal Roofing System” Installation Procedure provided by the client. Note, Sheathing and underlayment were used in the test frames as mentioned in the assembly details section of this report.

One 3' x 3' test deck consisting of a 36mm x 45mm wood batten frame with $1\frac{5}{32}$ " thick A-C Exterior Grade, Group1 Plywood, Tigerpaw Synthetic Roofing Underlayment. The Metal roof tiles were installed on the deck following the manufacture's installation instructions. The test was conditioned at a temperature of 73°F until the deck lumber had a maximum moisture content of 12%. See Appendix and Photograph section of this report for additional details of the assembly and profile tested.

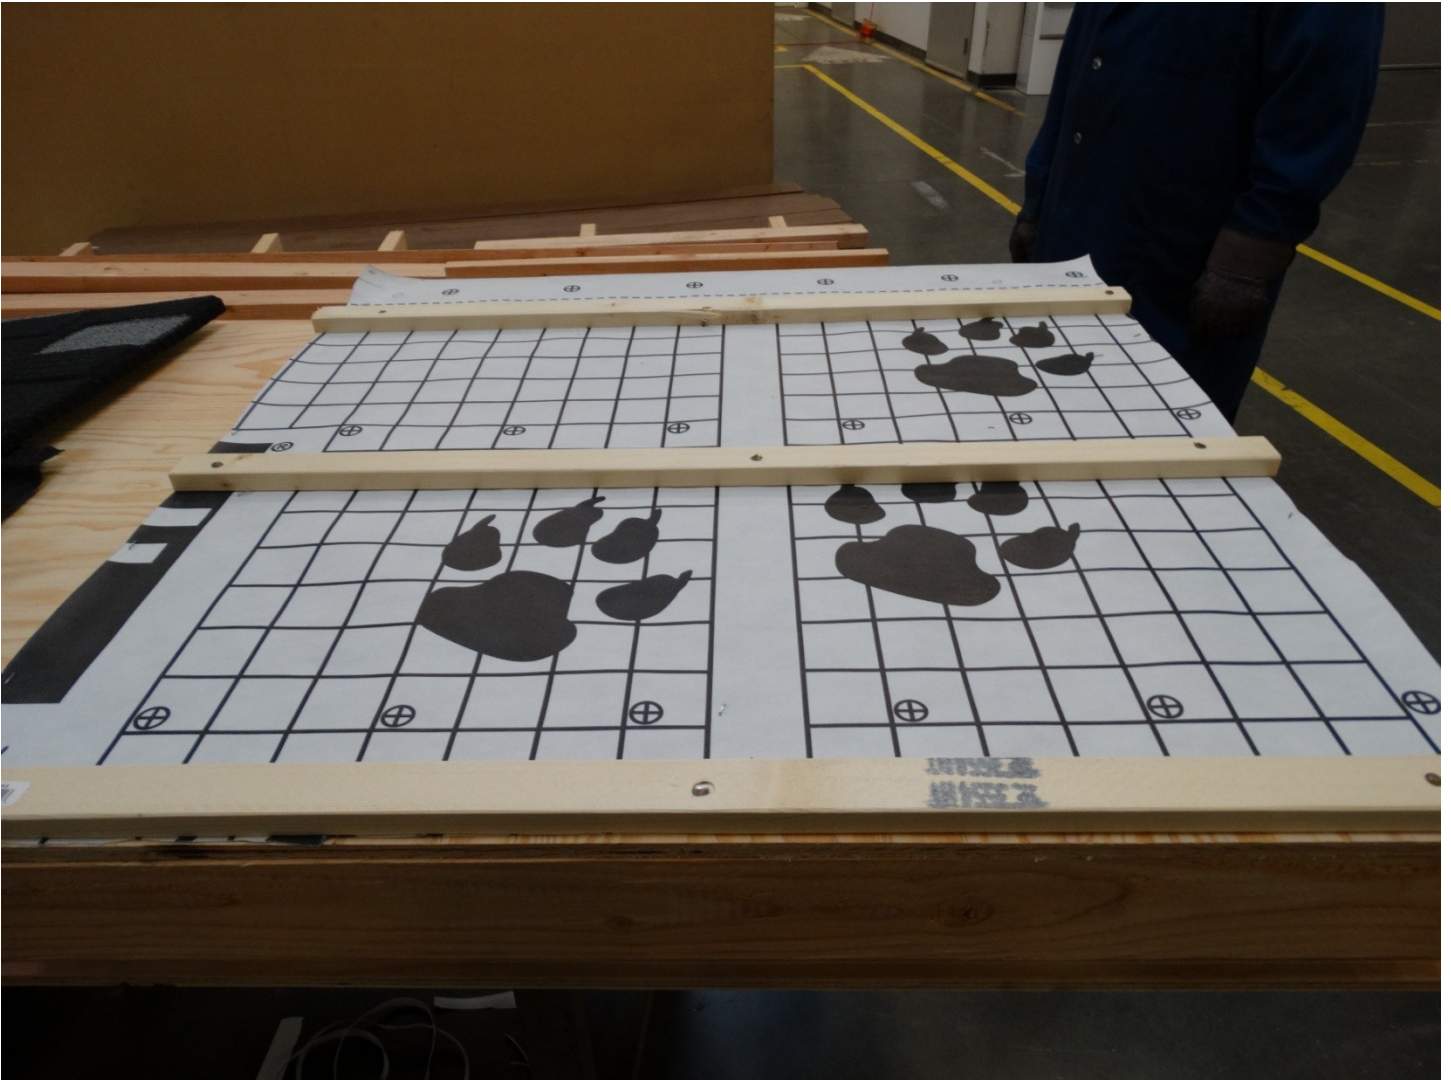
Photo1: 3x3 test deck with Tigerpaw Synthetic Underlayment and wood Battens.

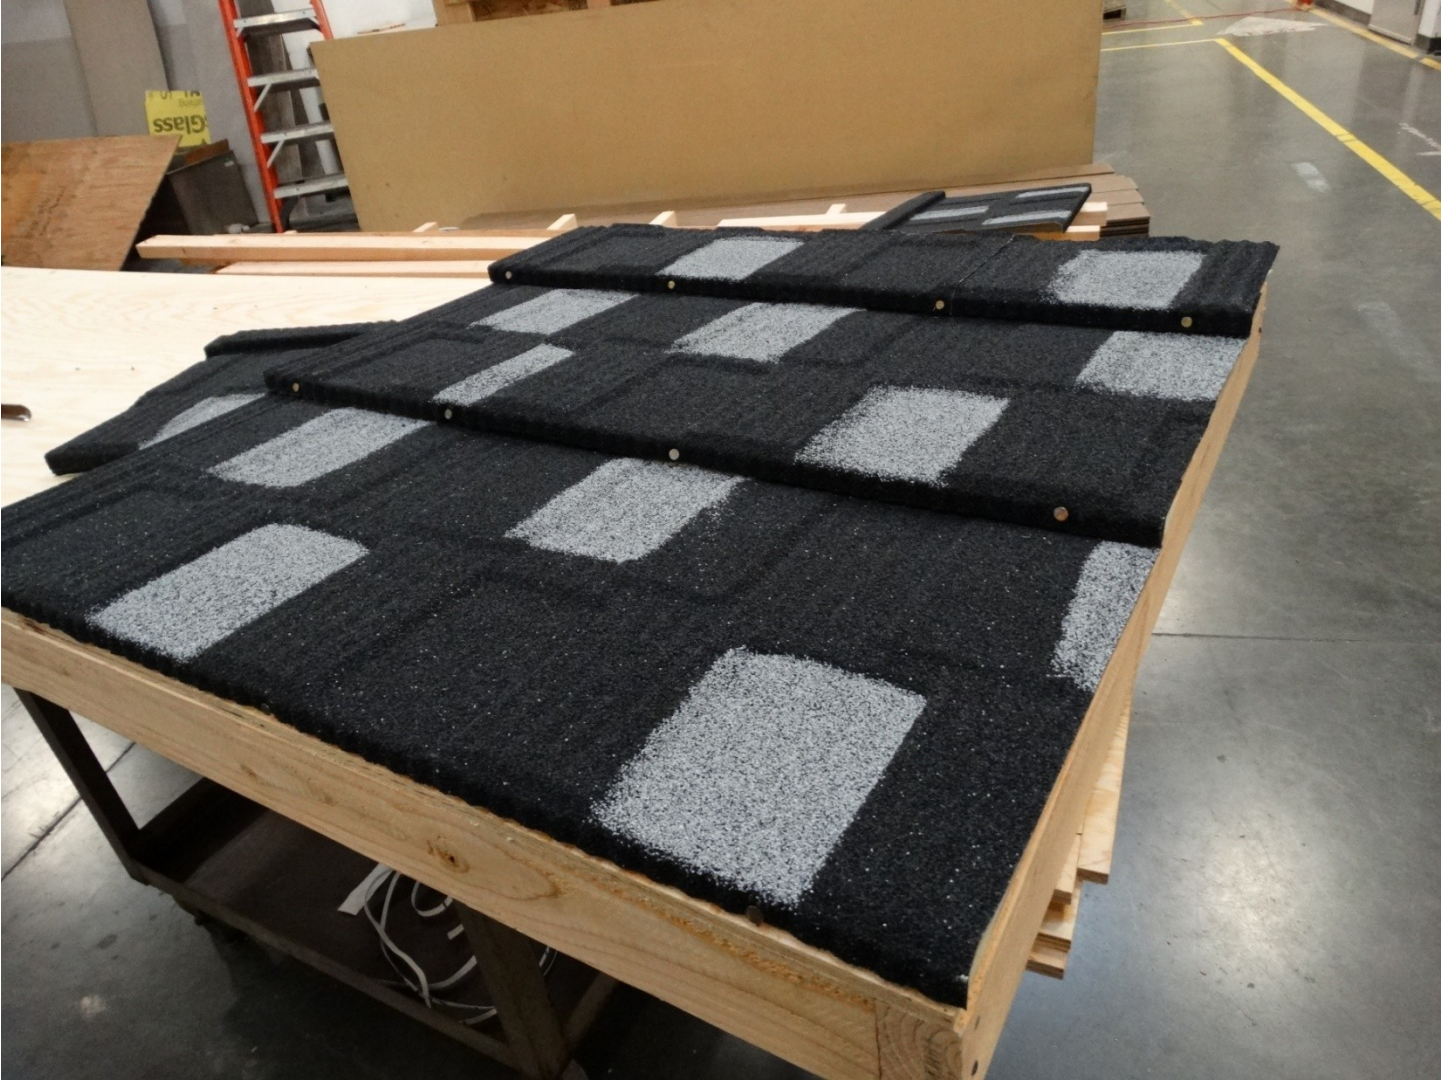
Photo2: UL2218 Test Deck Assembly from the top.

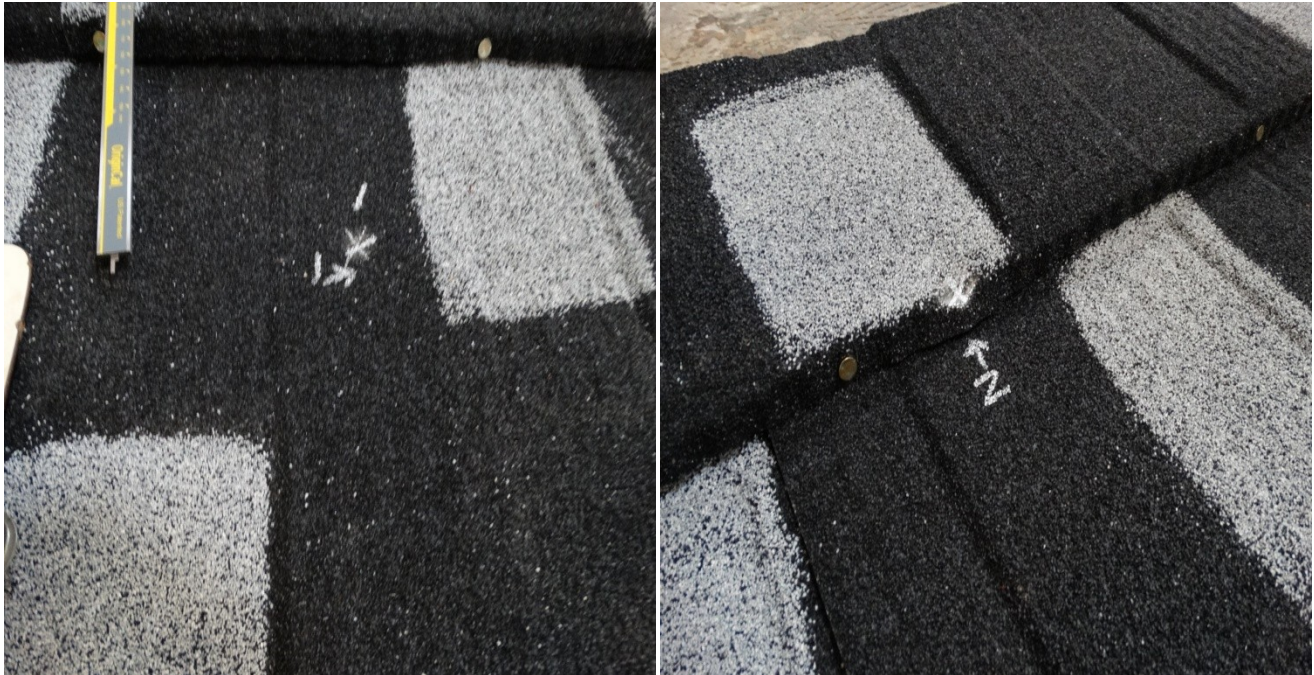
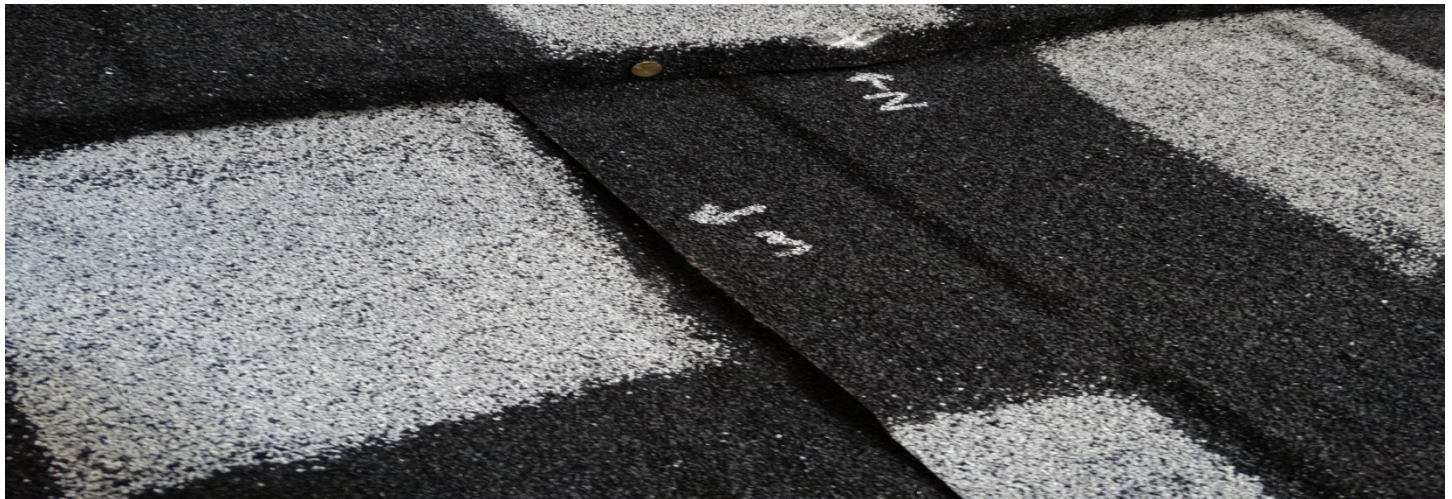
Photo 3:

Drop 1 (Flat Surface), Drop 2 (Tile Edge), Drop 3 (Unsupported Area).

Drop Location	Drop No.	Depression Depth (in)
Flat Surface	1	0.365
Flat Surface	2	0.388
Tile Edge	1	0.286
Tile Edge	2	0.365
Unsupported Area	1	0.460
Unsupported Area	2	0.516
Tile Joint	1	0.293
Tile Joint	2	0.327
Tile Corner	1	0.310
Tile Corner	2	0.451
Tile Edge	1	0.319
Tile Edge	2	0.458

No tearing, fracturing, cracking, splitting, rupture, crazing or other evidence of opening through any prepared roof covering layer was observed at any of the twelve impact locations when viewed through 5X magnification.

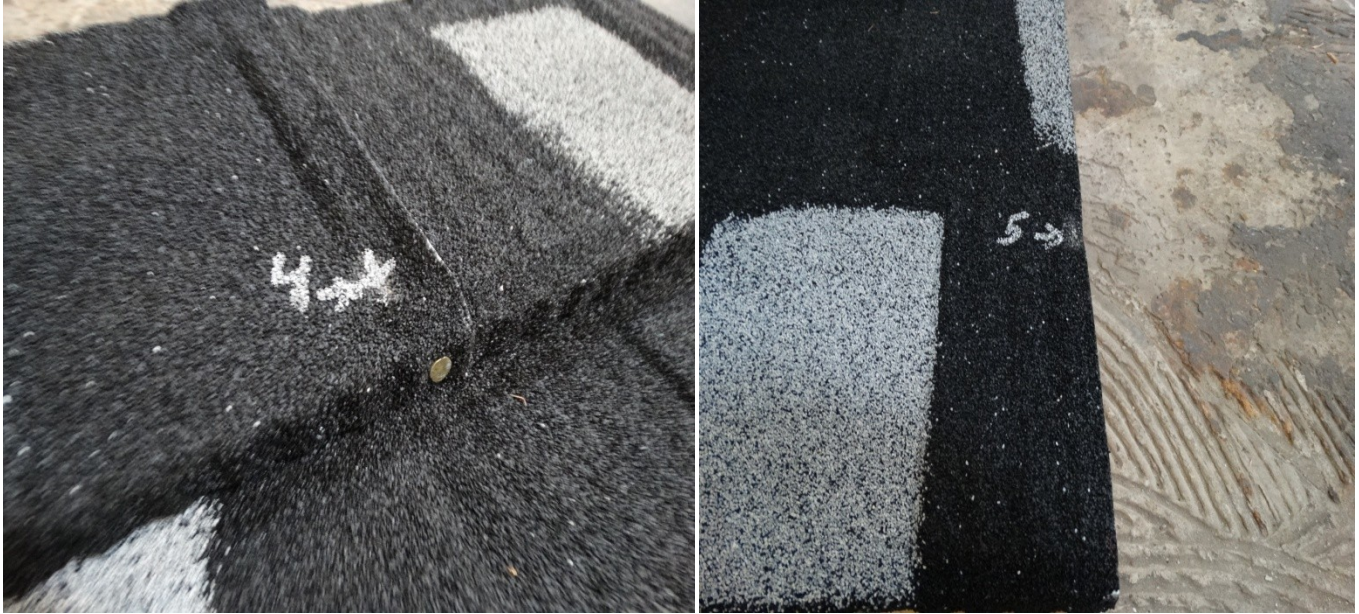
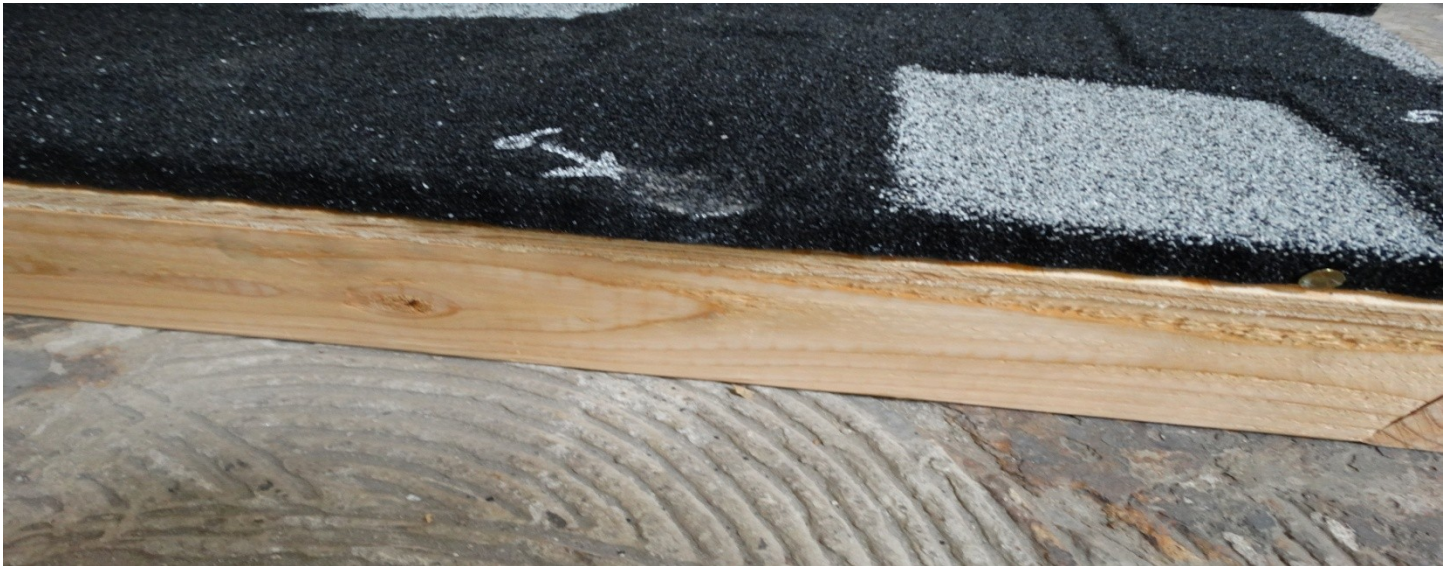
Photo 4:
Drop 4 (Tile Joint), Drop 5 (Tile Corner), Drop 6 (Tile Edge).

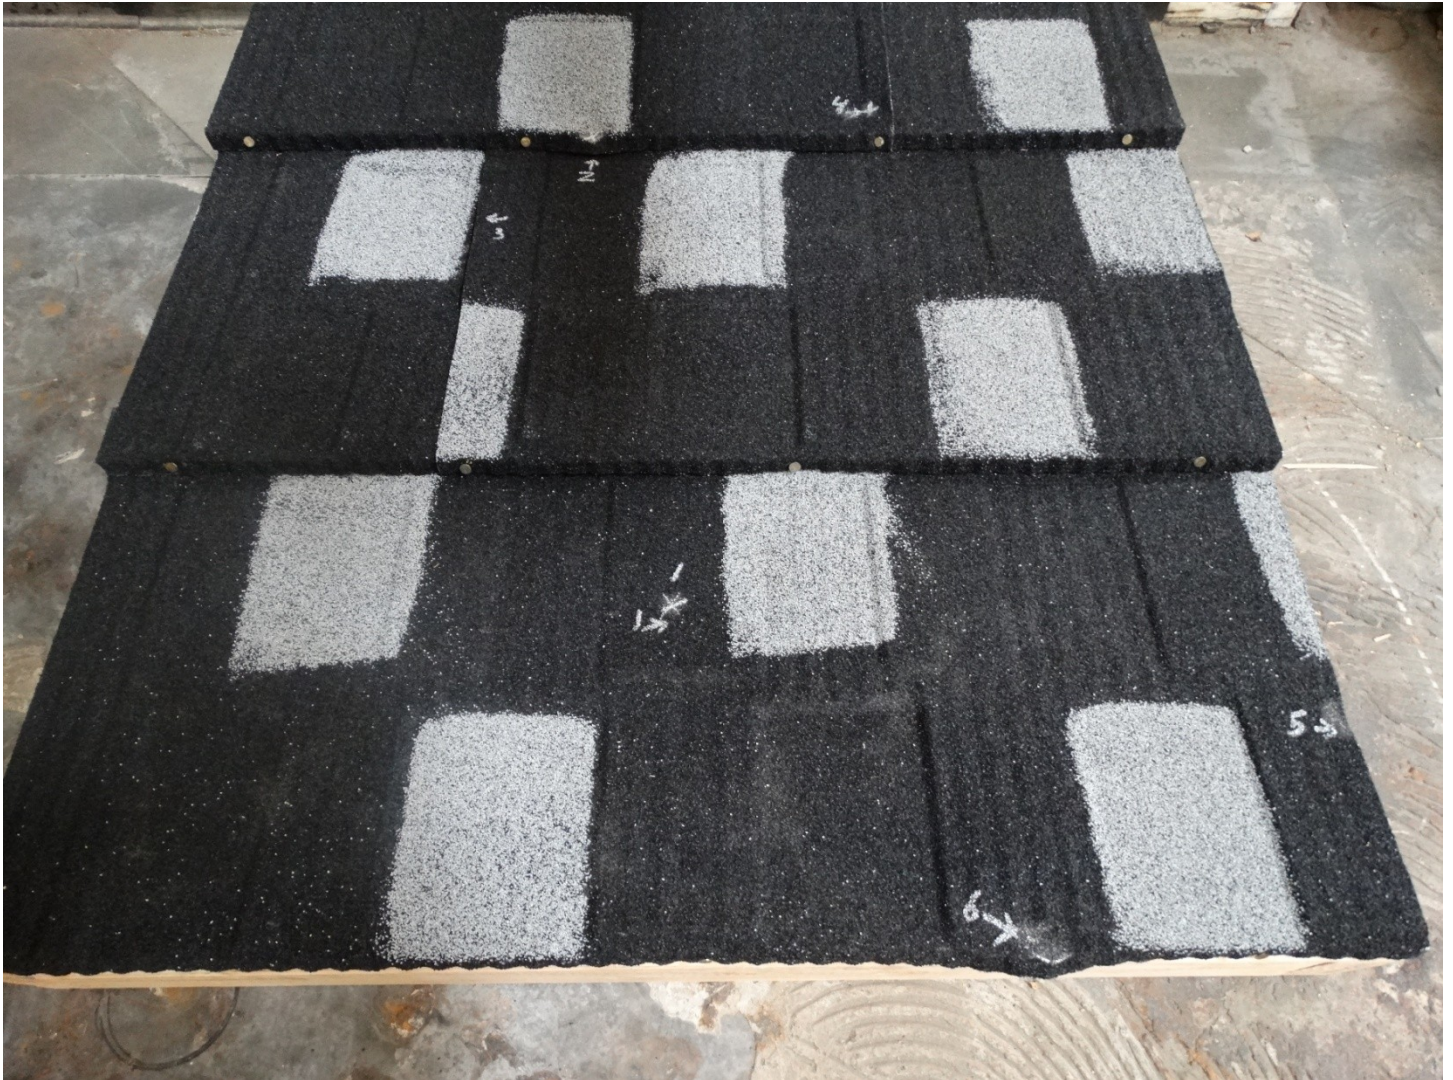
Photo 6:

Test deck assembly after two coincident drops at six different locations using a 2" diameter steel ball dropped from a height of 20 feet.
